Success Story

Application: Food Production Conveyor

Introduction

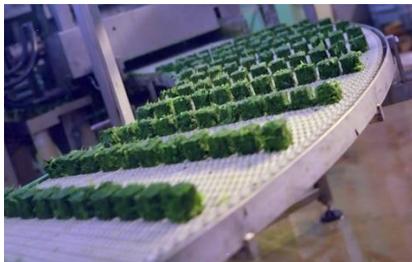
↑ Conveyor belt

- Problem: Regular high-pressure wash-downs led to corrosion, seal damage and grease wash-out from the bearings, resulting in regular bearing failure and production downtime
- Approx. bearing life: 4 to 6 weeks

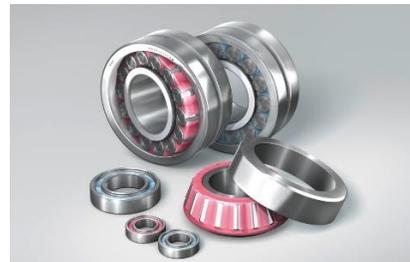
↑ Molded-Oil Bearings

- PBT thermoplastic resin housing
- Molded-Oil inserts (with solid lubricant)
- Martensitic stainless steel

- Nitrile rubber seals
- Available in Pillow Block, 2 and 4 bolt flanges and take-up unit housings

- NSK reviewed the bearing application and discovered that bearing corrosion and grease wash out were the main issues
- A trial was proposed using Stainless steel Molded-Oil bearing inserts

- After 12 months the bearings were still performing well with no failures
- From this trial the solution was applied to other similar applications generating significant cost savings
- This success was then transferred to other production sites within the company
